Pro38 BULLETIN

Forward Closure Failures

June 15, 2016

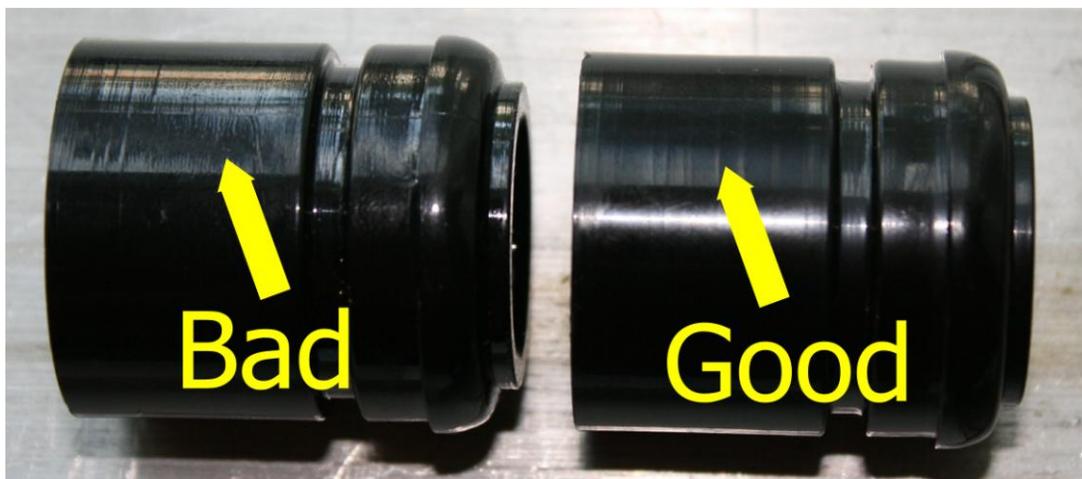
It has been brought to the attention of Cesaroni Technology Inc this past week that there has been a high failure rate on several types of Pro38 motors due to forward closure failures. Upon investigation, the root cause has been identified as a failure from de-bonding between the adhesive/epoxy and the forward closure wall. This adhesive is used to hold the delay grain within forward closure housing, and when a poor bond occurs under pressure this can lead to hot gases tracking through forward closure interface resulting in the failures shown.

With further investigation into the recent cause, our manufacturing records showed that our resin supplier of the material used while injection molding the forward closure housing had accidentally sent one (1) of four (4) box of material which was slightly different. This mislabeled box contained the same material but had an added lubricant/surfactant, which is compounded directly into the resin to promote/enhance flow during the injection molding process. The introduction of this resin lubricant has caused a bonding compatibility issue with the adhesive/epoxy CTI uses during potting of the delay grain within the forward closure assembly. CTI has already discussed this matter with our resin supplier to ensure this does not happen again.

Unfortunately the forward closure housing itself does not have a unique serial date to identify the effected motors. In a side by side comparison between bad & good forward closures it is extremely difficult to visually identify the difference. With a very keen eye, under the proper lighting & reflection conditions there is a tiny difference that can be seen. The surface of the bad forward closures will appear to be slightly "wavy."

Again not all of these ProX reloads will necessarily have faulty/bad forward closures. However CTI understands the work & effort the HPR community places into their model rockets and how devastating it can be if a failure occurs. As such to rectify this issue CTI will supply all of the listed dealers with replacement forward closures. Any HPR customer who believes they may have a "potentially" affected forward closure can contact their ProX dealer where they purchased the reload. The dealer will provide at no cost the replacement forward closure. Please identify to your dealer in advance the exact reload model number to receive the appropriate forward closure/delay module. Please dispose of the faulty forward closure/delay module as outline in the instructions and SDS.
